**A SEMI-ANNUAL AQUATIC MONITORING REPORT FOR
AQUATIC SAMPLE SITE BRFK-4 LOCATED NEAR ROARING
FORK IN WISE COUNTY, VIRGINIA**

**Prepared for:
Red River Coal Company, Inc**

ATS PROJECT NO. 1199.01

May 2014

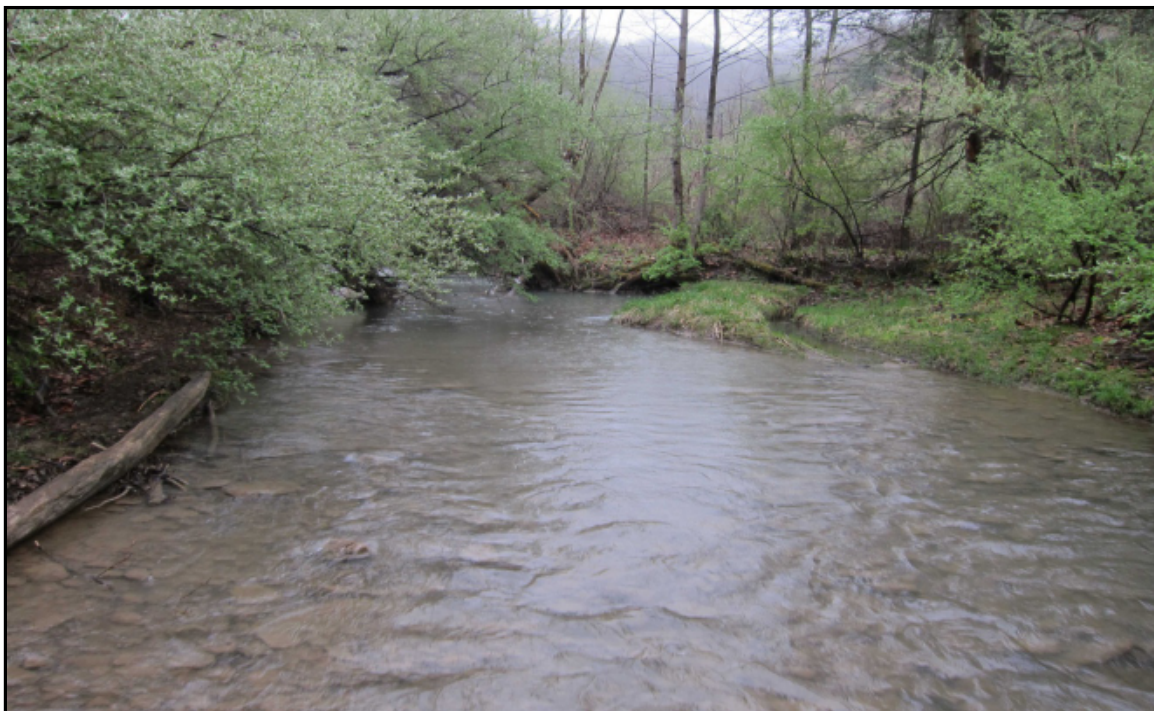
Figure 12: BRFK-4 upstream view

The stream habitat at BRFK-4 scored 140 of 200 (Appendix A), indicating the habitat is partially supporting its designated use. The stream was approximately 20 feet wide and characterized mostly by a series of riffles and runs (Figures 12 and 13). Flow occupied >75% of the stream channel. Embeddedness was suboptimal with approximately 25 to 50% of the substrate particles surrounded by fine sediment. The coloration of the water was clear but there was evidence of slight to moderate sedimentation within the streambed. Both stream banks were stable and good with riparian zones.
